# **INDOOR AIR QUALITY ASSESSMENT**

**Devens Conference Center  
100 Sherman Avenue  
Devens, Massachusetts**

Prepared by:  
Massachusetts Department of Public Health  
Bureau of Environmental Health Assessment  
Emergency Response/Indoor Air Quality Program  
August 2003

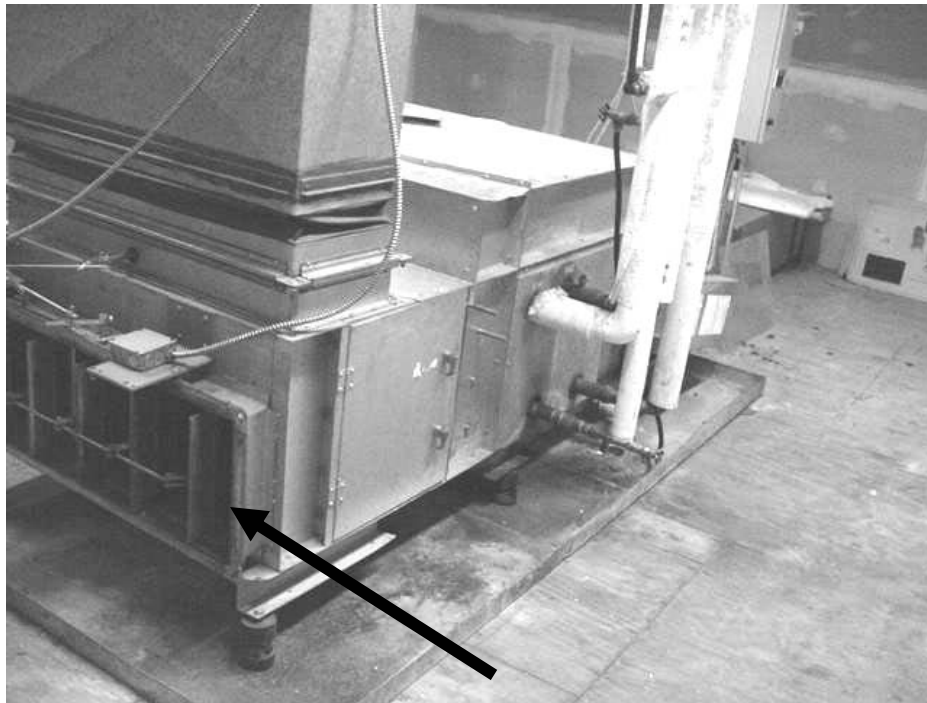
**Picture 1**

Air handling units (AHUs) provide fresh air. AHUs are located in mechanical rooms (see Picture 1). Fresh air in occupied spaces is supplied by ceiling mounted fresh air diffuser connected to AHUs via ductwork. Air is exhausted from occupied spaces through ceiling mounted return vents connected to ductwork. The return vent ducts terminate in the wall of the AHU rooms (see Picture 2). Instead of installing ducts to connect the return vents to AHUs, the entire room was designed to serve as a return duct. The return air vent on each AHU is open to the room (see Picture 1). In this configuration, the AHU becomes depressurized which draws air from the return air ducts and in turn, the occupied spaces.

**AHU Room, Note Open End of AHU**

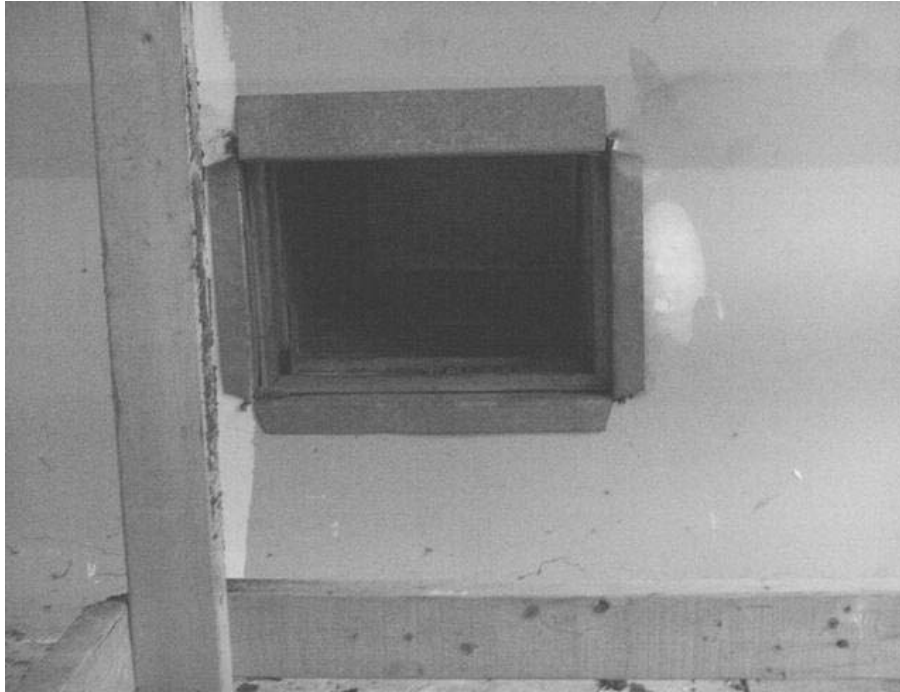
**Picture 2**

**Return Vent Ducts Terminate in the Wall of the AHU Rooms**

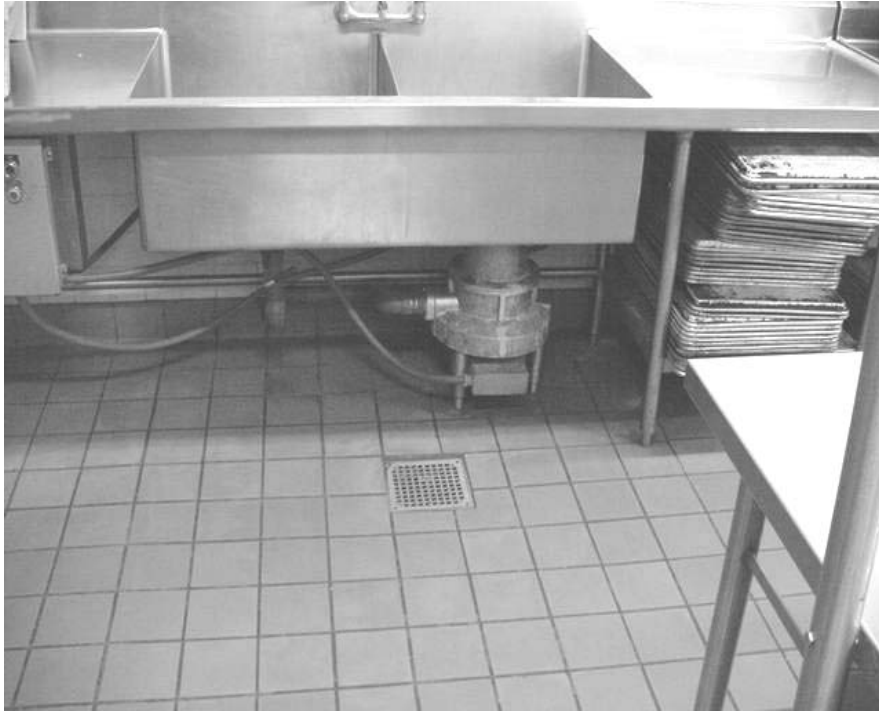
**Picture 3**

1. A septic system odor and the smell of rotting food were detected around a sink (see Picture 3). A garbage disposal in the sink that had not reportedly been used for some time. It is likely that the trap within the disposal was dry, allowing for septic system odors to backup into the kitchen. In addition, food residue within the disposal itself likely decayed, producing the rotting food odor. Running water into the sinks drain and activating the garbage disposal for several minutes reduced/eliminated the odor.

**Garbage Disposal/Sink**

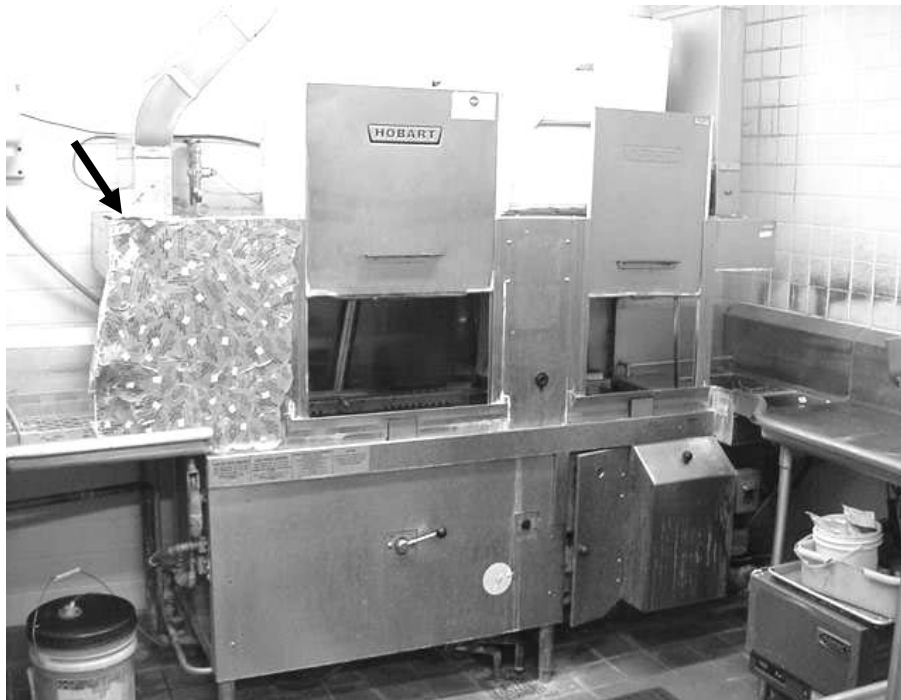
**Picture 4**

2. A similar odor was detected in the dishwashing room from an inactive automated dishwasher. As this machine operates, odors and steam are vented by a duct system. When the automated dishwasher is deactivated, odors from food residue and the dry drain trap are not expelled from the building. In addition, the exterior lid covers of the automated dishwasher are covered with food (see Picture 4). Remaining food residue on these covers may also be a source of odor.

**Automated Dishwasher, Note Containers Adhered to Cabinet**

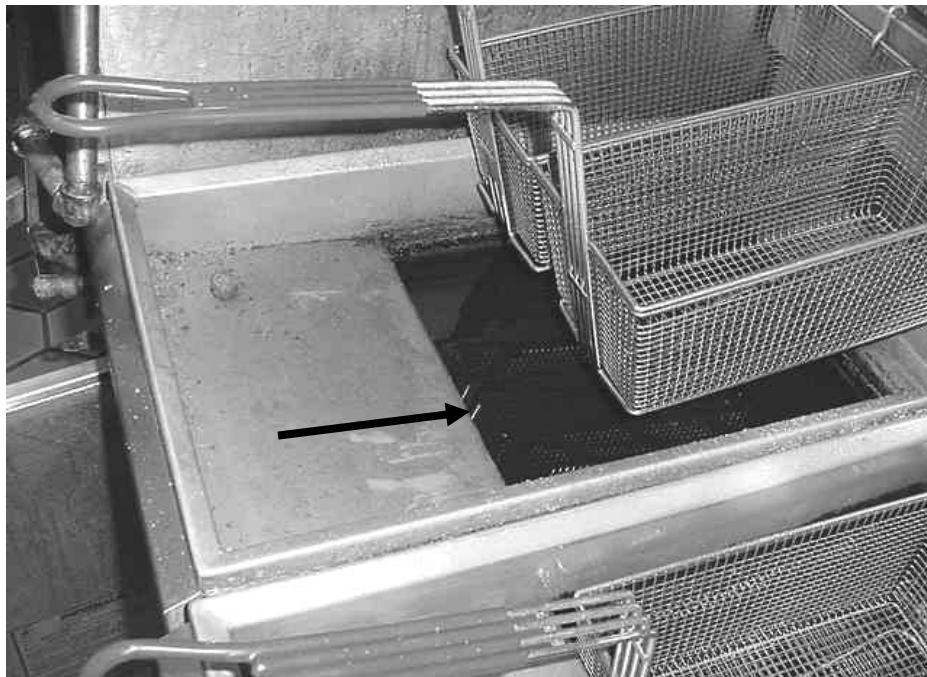
**Picture 5**

3. The front of the kitchen had a friolator with standing oil (see Picture 5). It is likely that the cooking oil odors are due to this source.
4. Cooking equipment had heavy residues(s). Areas underneath kitchen equipment were also heavily coated with dirt and cooking debris (see Pictures 6 through 8).

**Friolator, Note Oil**

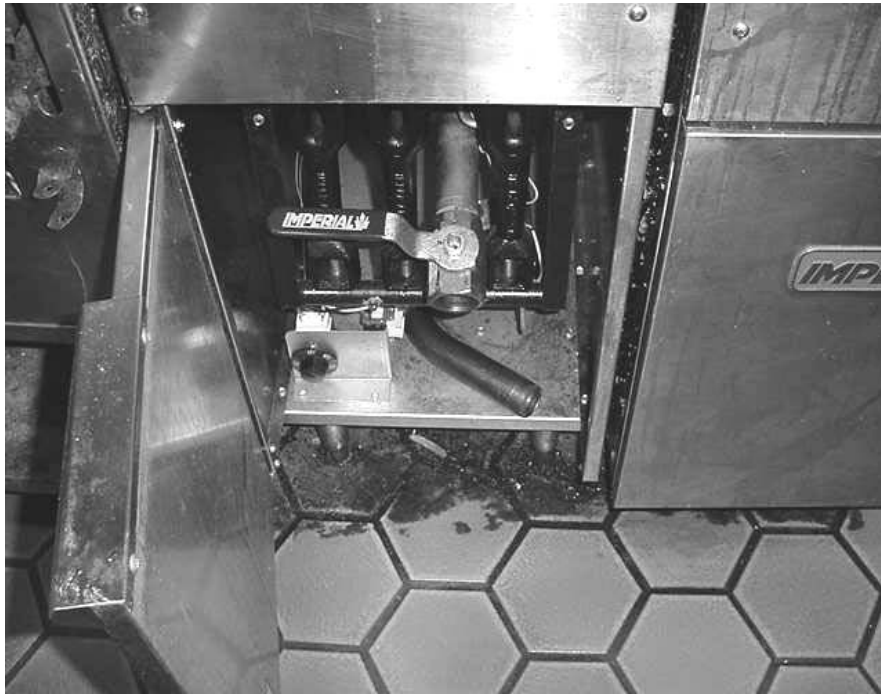
**Picture 6**

**Accumulated Residue beneath Kitchen Equipment**

1. Operate the kitchen exhaust vents during building occupancy regardless of kitchen operations.
2. Continue with plans to thoroughly clean the kitchen area to remove food residues from on and around kitchen appliances as well as building surfaces (e.g. walls and ceilings).
3. Use of integrated pest management (IPM) to rid the building of pest is highly recommended. A copy of the IPM recommendations can be obtained from the Massachusetts Department of Food and Agriculture (MDFA) website at the following website: [http://www.state.ma.us/dfa/pesticides/publications/IPM\\_kit\\_for\\_bldg\\_mgrs.pdf](http://www.state.ma.us/dfa/pesticides/publications/IPM_kit_for_bldg_mgrs.pdf).

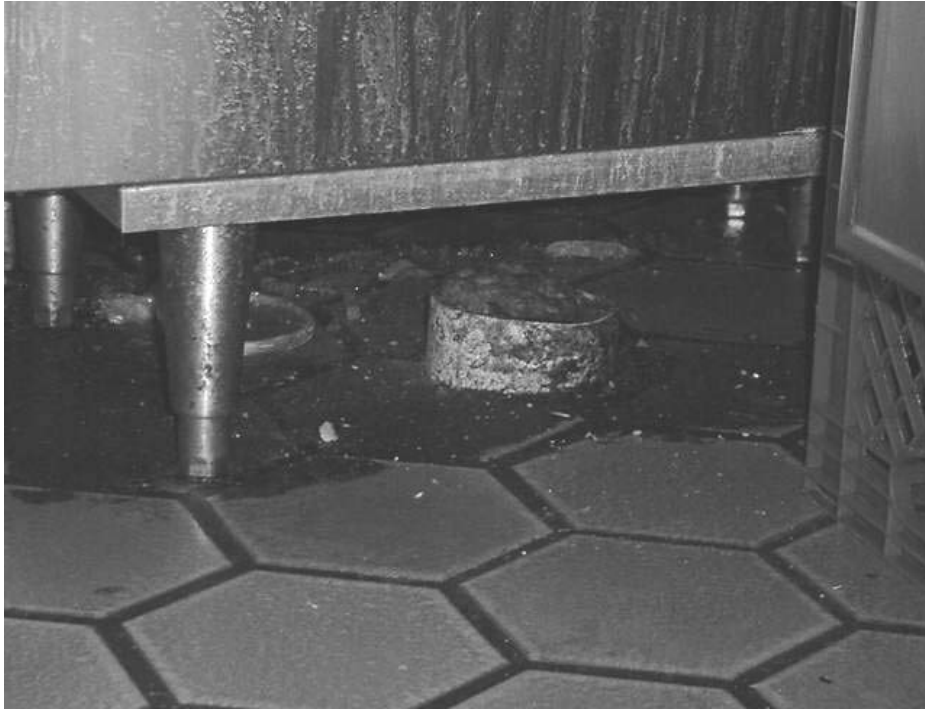
**Picture 7**

**Accumulated Residue beneath Kitchen Equipment**

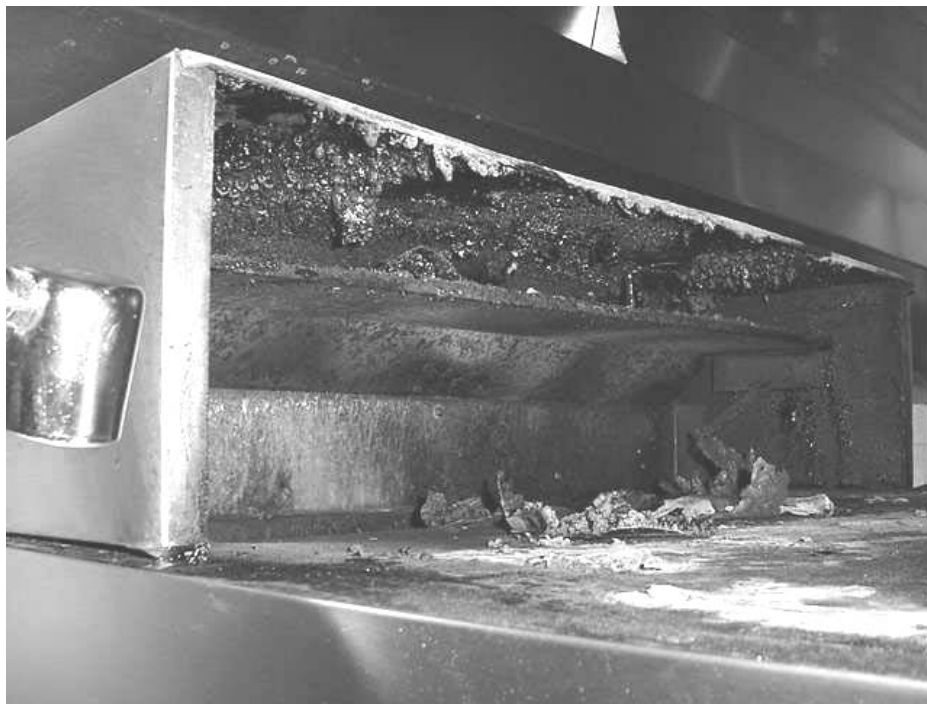
**Picture 8**

**Accumulated Residue beneath Kitchen Equipment**

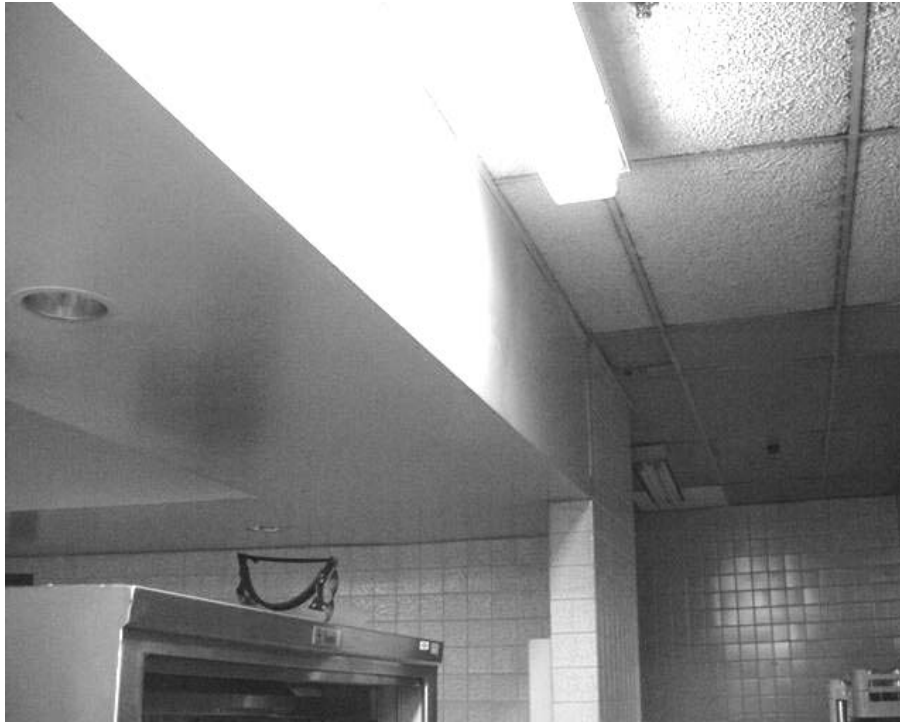
**Picture 9**

5. The ceiling and walls near the front of the kitchen were discolored with a heavy coating of cooking residue (see Picture 9 and 10).
6. The oven/stove is gas fueled with operating pilot lights. Products of gas combustion were detected around the oven/stove.

**Ceiling Discolored in the Front Kitchen with a Heavy Coating of Cooking Residue, Note Color Difference in Ceiling Tiles**

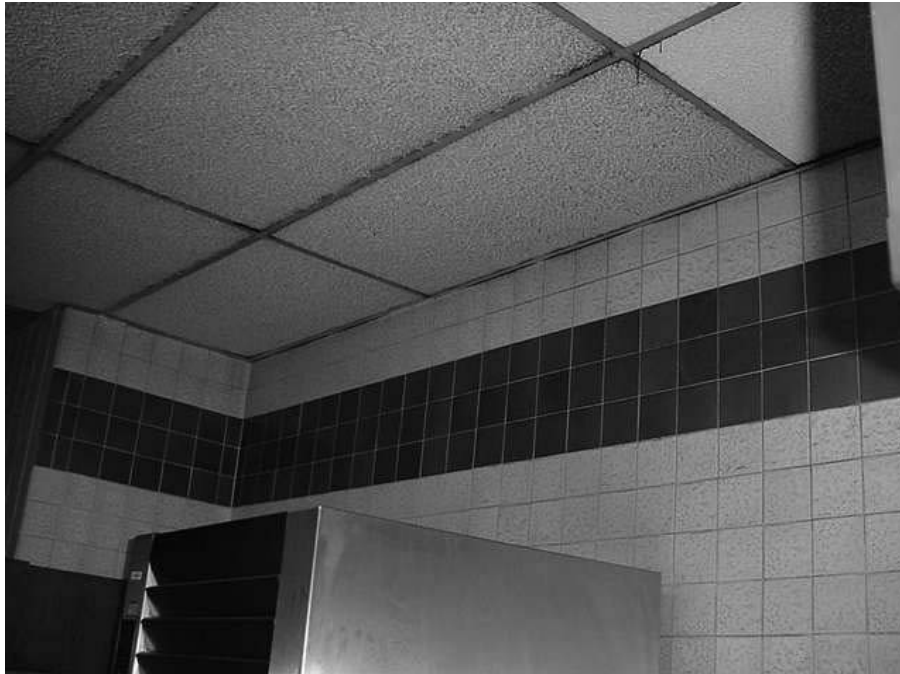
**Picture 10**

**Ceiling Discolored in the Front Kitchen with a Heavy Coating of Cooking Residue, Note Color Difference in Ceiling Tiles**

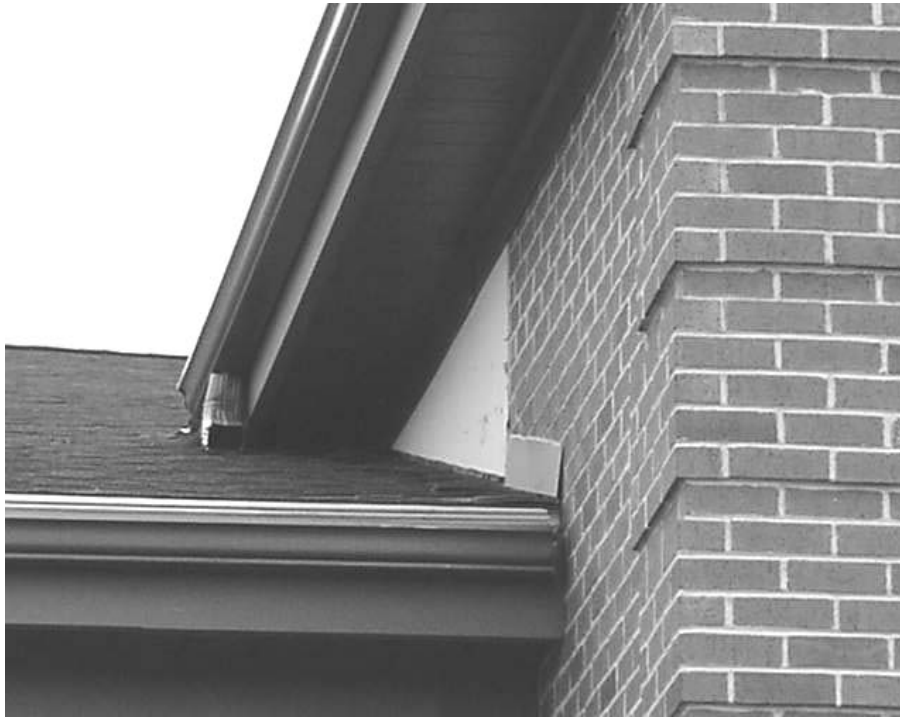
**Picture 11**

Sources of possible microbial contamination were noted in some areas of the building, but would not be expected to produce the symptoms described by conference attendees. Water damage was noted in a fire door vestibule located off the conference room. Water damaged gypsum wallboard (GW) clad with vinyl wallpaper was seen in this area. GW, wallpaper and wallpaper paste can serve as media for mold growth. The source of the water damage is likely the result of the design/configuration of the roof drainage system over the fire door. The DCC has a peaked roof. The roof is configured with one section above the level of another (see Picture 11). In order to provide rainwater drainage from the upper roof, a gutter and downspout was installed. The downspout empties directly on the lower roof and the roof wall junction. This is located directly over the water damage above the fire door. This configuration also allows the roof/exterior wall junction to become saturated, resulting in water penetration. Other damage to the roof system was noted (see Picture 12). A panel outside the kitchen was bent outwards, which may allow moisture to penetrate into the building. The American Conference of Governmental Industrial Hygienists (ACGIH) recommends that porous building materials be dried with fans and heating within 24 hours of becoming wet (ACGIH, 1989). If not dried within this time frame, mold growth may occur. Water-damaged porous materials (e.g. GW and carpeting) cannot be adequately cleaned to remove mold growth. The application of a mildewcide is not recommended.

**Gutter/Downspout System above Water Damage in Conference Room Fire Door Vestibule**

- f. Reduce harborages (cardboard boxes) where rodents may reside (MDFA, 1996).
4. Seal breeches in the AHU walls made to repair sprinklers.
  5. Reconfigure the gutter/downspout system to empty into the main roof gutter (Picture 11).

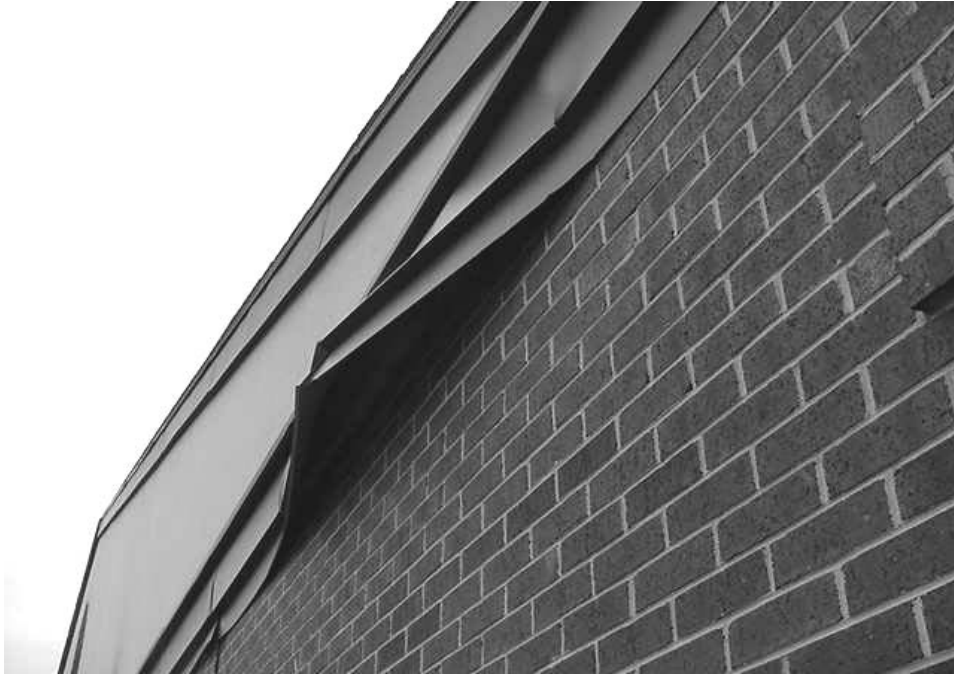
**Picture 12**

**Damage to Roof System outside Kitchen**

6. Repair the damage to the roof system (Picture 12).
  7. Remove and replace any mold contaminated/water damaged GW and wallpaper. This measure will remove actively growing mold colonies that may be present. Remove mold contaminated materials in a manner consistent with recommendations found in “Mold Remediation in Schools and Commercial Buildings” published by the US Environmental Protection Agency (US EPA, 2001).

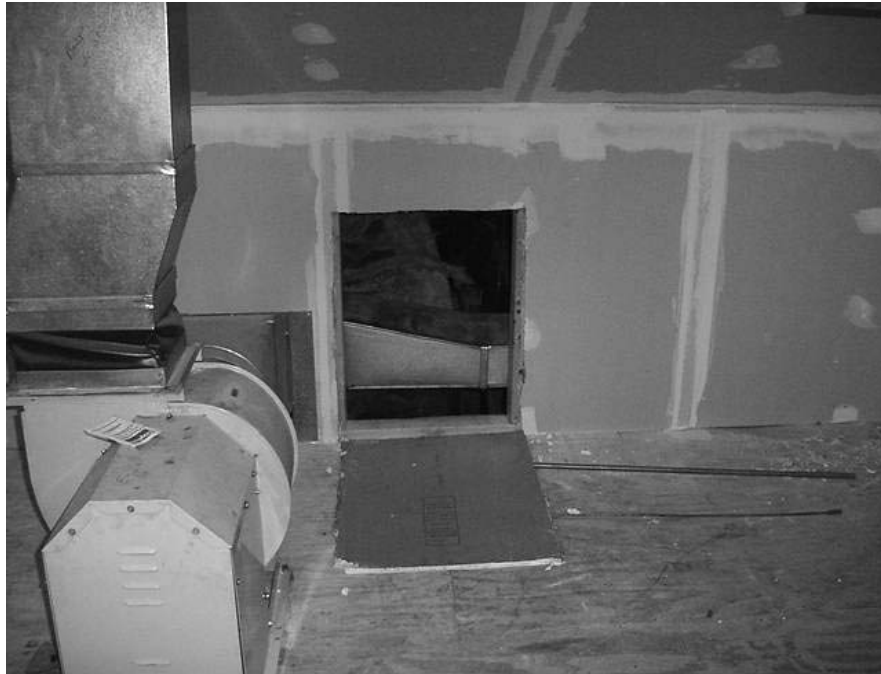
**Picture 13**

rooms to get to areas above the ceiling. A number of these access holes were not sealed (see Pictures 13 through 15). Since the AHUs are not connected to return vent ducts, the depressurization created by the draw of air by AHUs draws air from the ceiling plenum. While this condition may have some role in distributing irritating pollutants to occupied areas, the conditions noted in the kitchen are the most likely source of odors reported by conference attendees.

**Access Holes in GW of AHU Room**

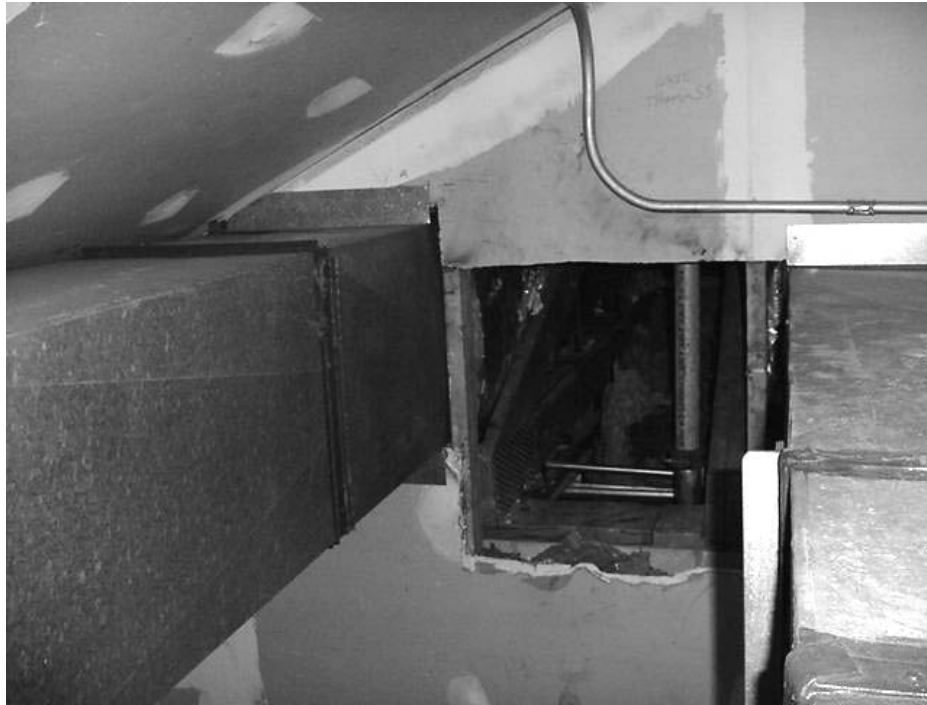
**Picture 14**

**Access Holes in GW of AHU Room**

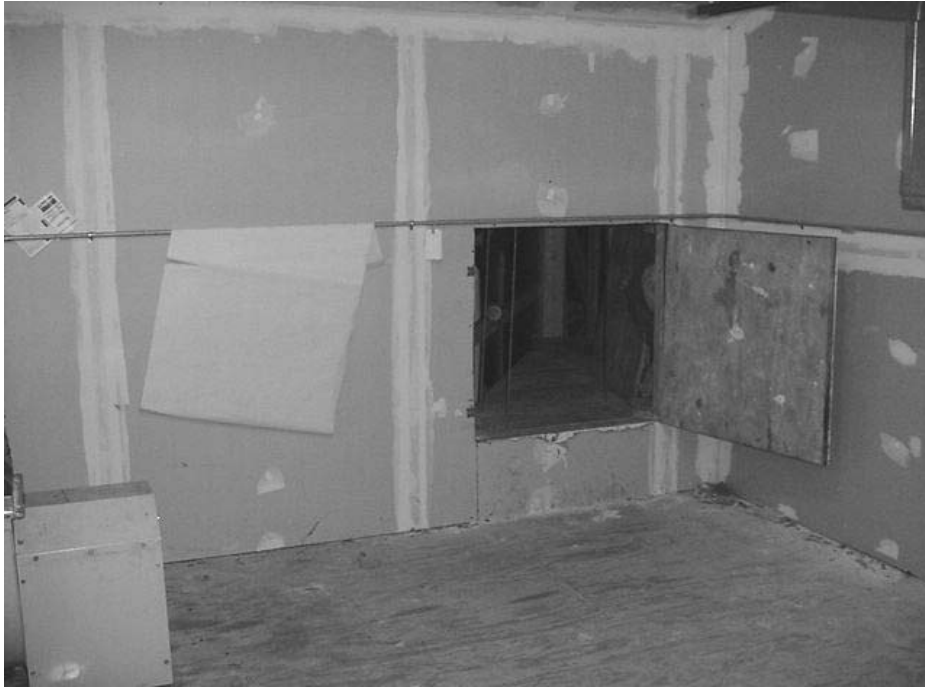
**Picture 15**

**Access Door in GW of AHU Room**
